# Cayucos Sustainable Water Project

## Preliminary Draft Site Analysis Report

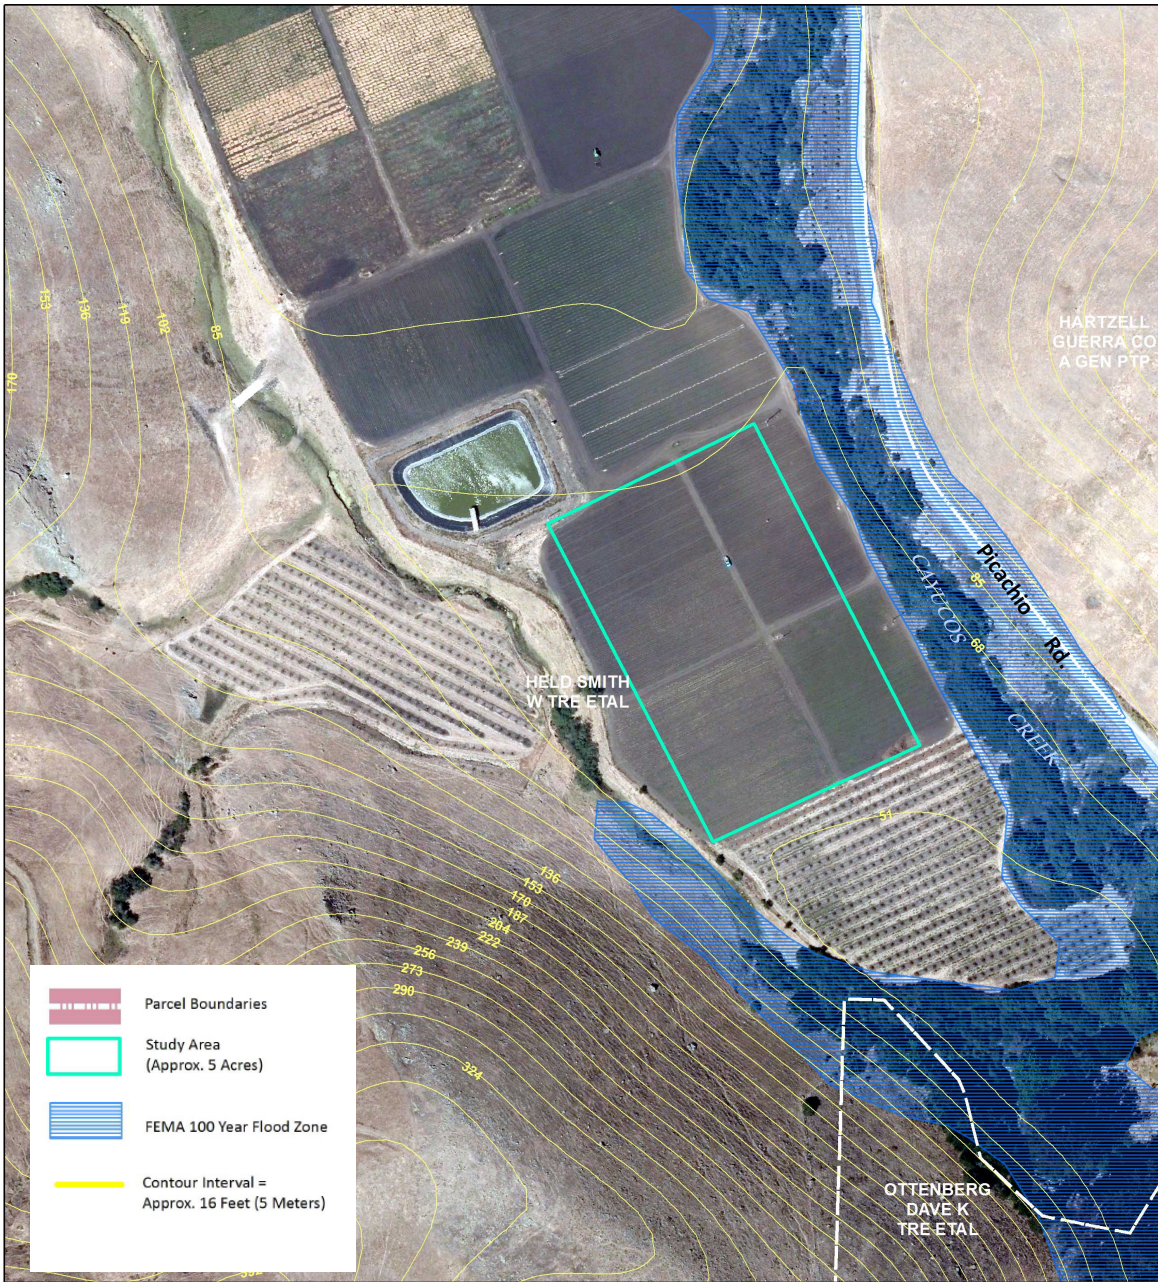
# Site 1 Cayucos Creek

**Geologic Hazard**

Minor

**Biologic Resources**

Creek Proximity, Access

**Cultural Resources**

Monitor Construction

**Agriculture**

Prime Soil
